Spot Safety Project Evaluation

Spot Safety Project # 11-01-200

Spot Safety Project Evaluation of the Installation of Advance Overhead “Yield to Pedestrians” Signs on NC 184/NC 194 (Main St) at Lees-McRae College Avery County

Safety Evaluation Group
Traffic Safety Systems Management Section
Traffic Engineering and Safety Systems Branch
North Carolina Department of Transportation

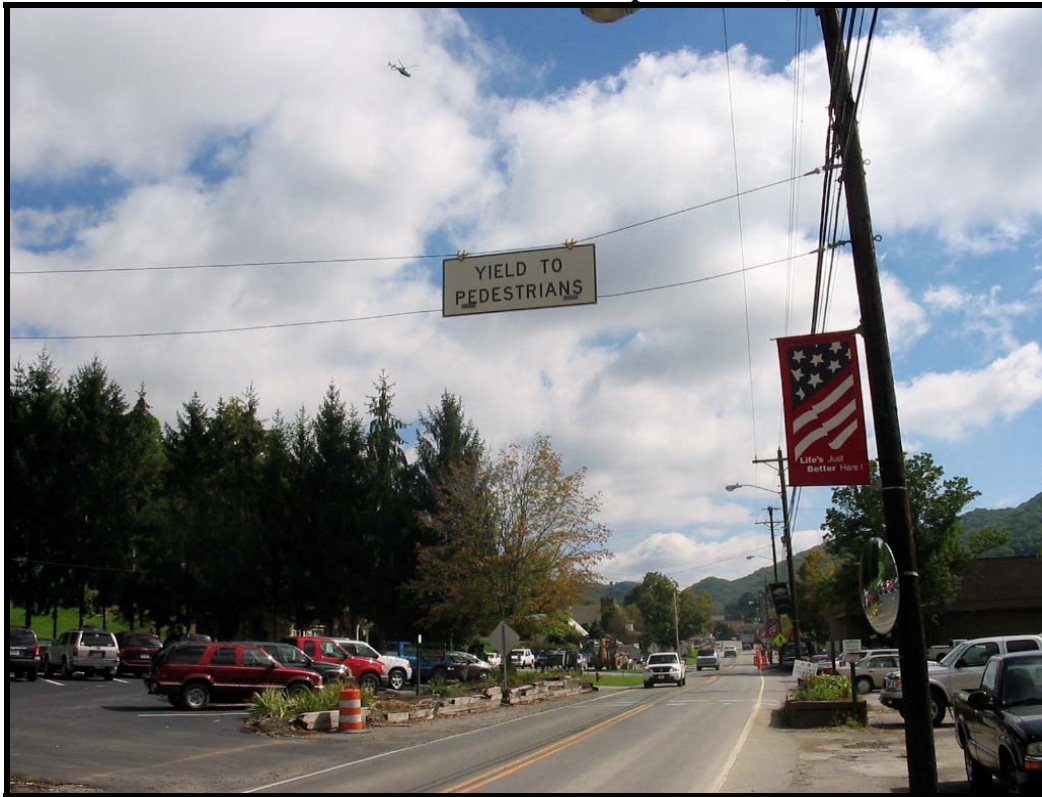
Taken on NC 184/194 Facing East

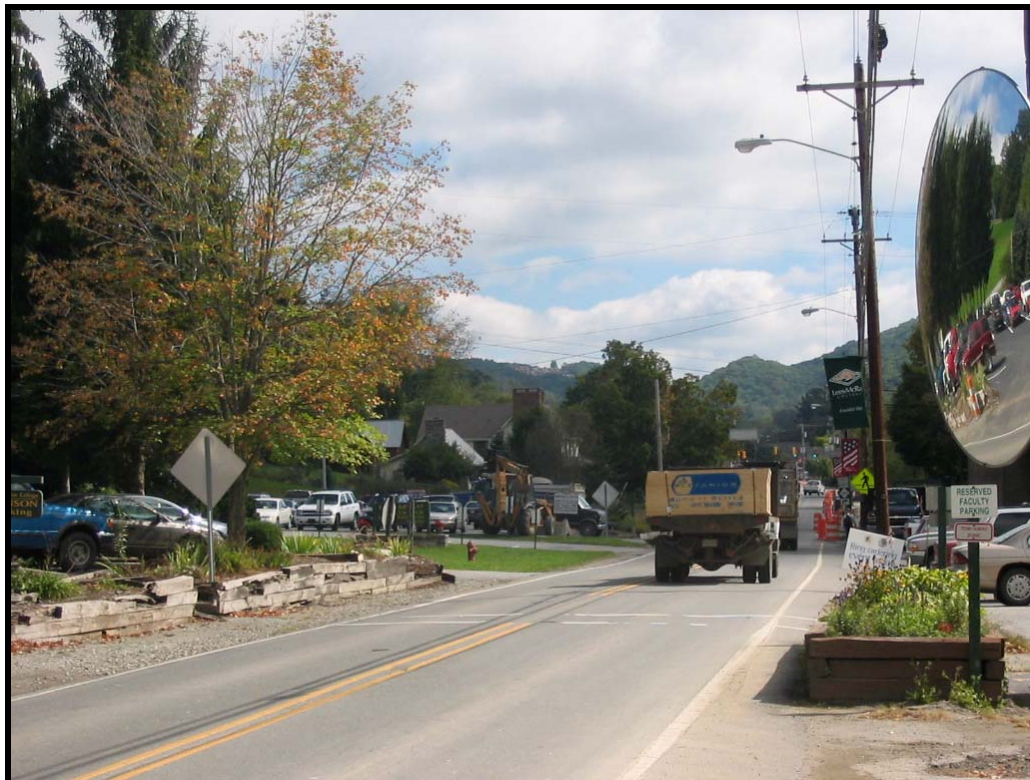
Facing East on NC 184/NC 194

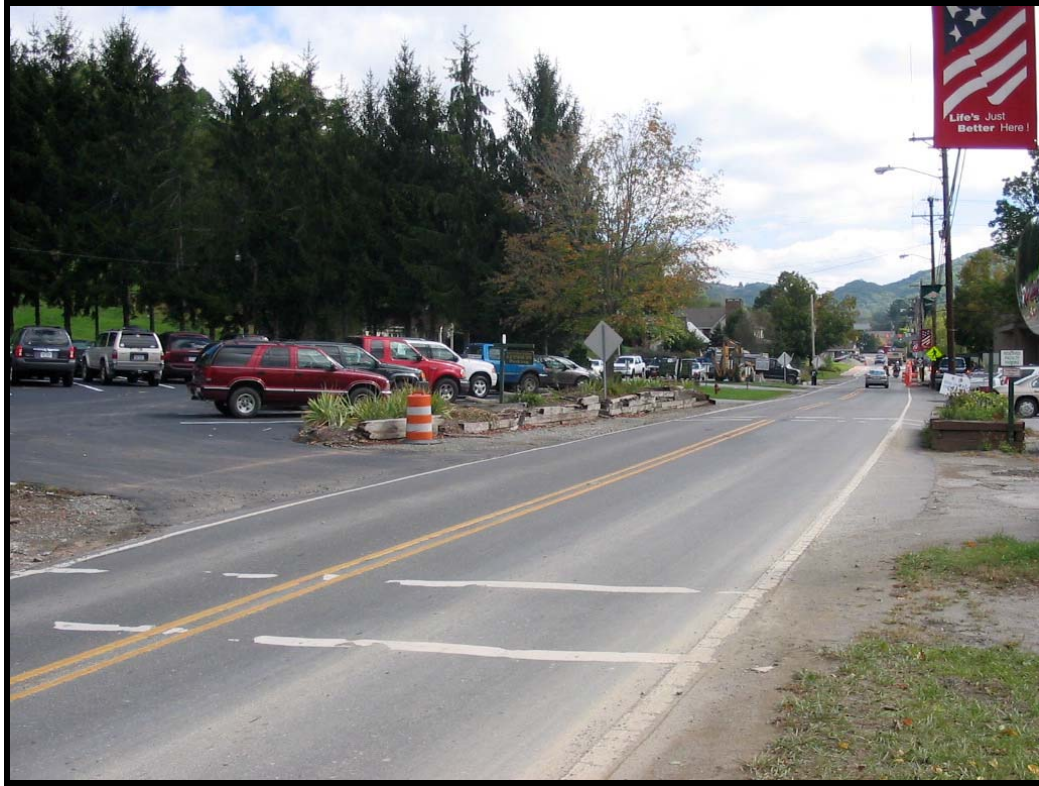
Facing East on NC 184/NC 194

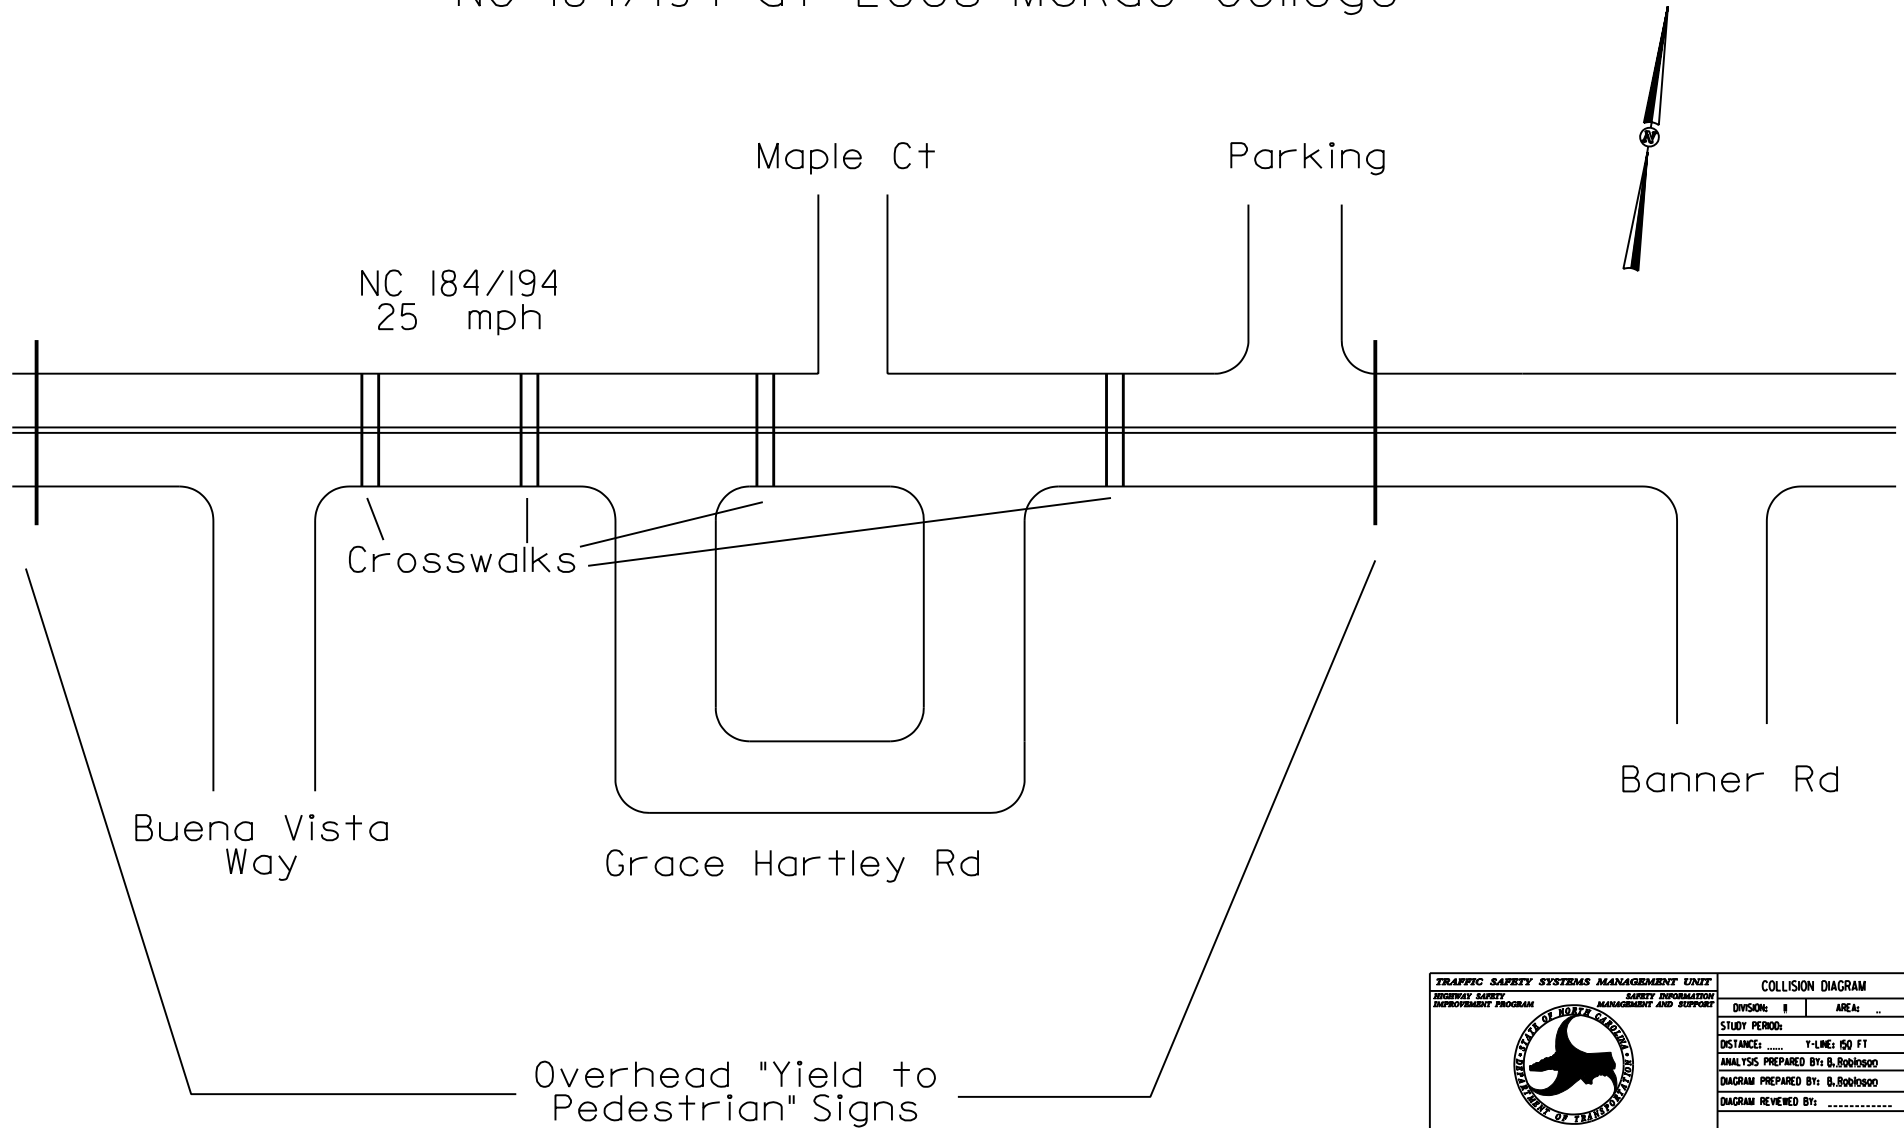
CONDITION DIAGRAM AVERY COUNTY NC 184/194 at Lees-McRae College

TRAFFIC SAFETY SYSTEMS MANAGEMENT UNIT <small>HIGHWAY SAFETY IMPROVEMENT PROGRAM</small>		COLLISION DIAGRAM

There were no crashes at the subject location in the before period and only one crash in the after period. The single crash in the after period involved a vehicle sliding on ice into a light pole. It did not involve a pedestrian.
